Manhole Inspection Summary

Manhole # S43UU_033MH

Insp Date: **2/12/07 1:59 PM**

Location Address: **1512 ABBOTTSTON ST**

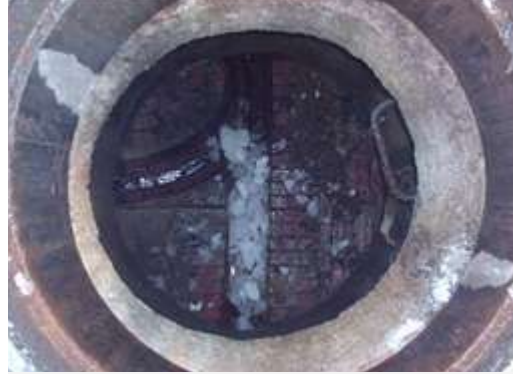
Top View

Corroded steps. Evidence of surcharge - Bench debris.

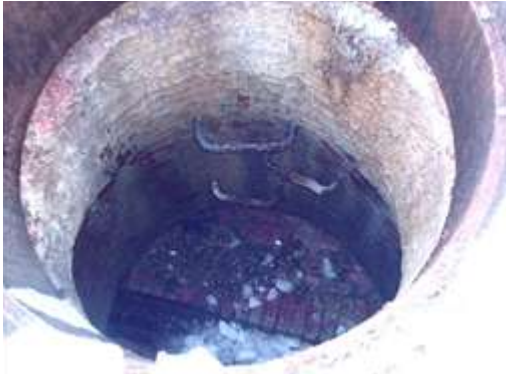
Defect

Frame leaks. Frame offset. Adjustment deterioration and infiltration. Barrel infiltration.

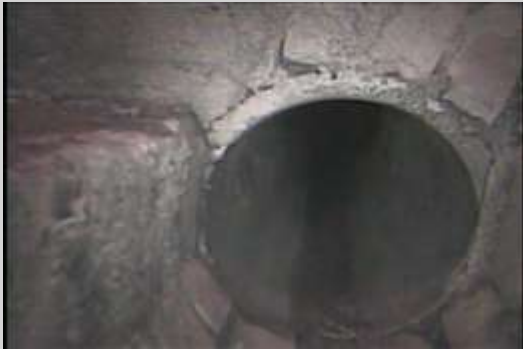
8 in. Circular Gravity Sewer Pipe Out @ 12 O'Clock

Infiltration: **Evidence** Pipe Seal Cond: **Unknown**
